## **Implementation and Application of Unmanned Aerial Systems (UAS) in a Diverse Public Utility Environment**

### **Abstract**

### **Unmanned Aerial Systems (UAS) use at LCRA**

## Engineering Applications of UAS

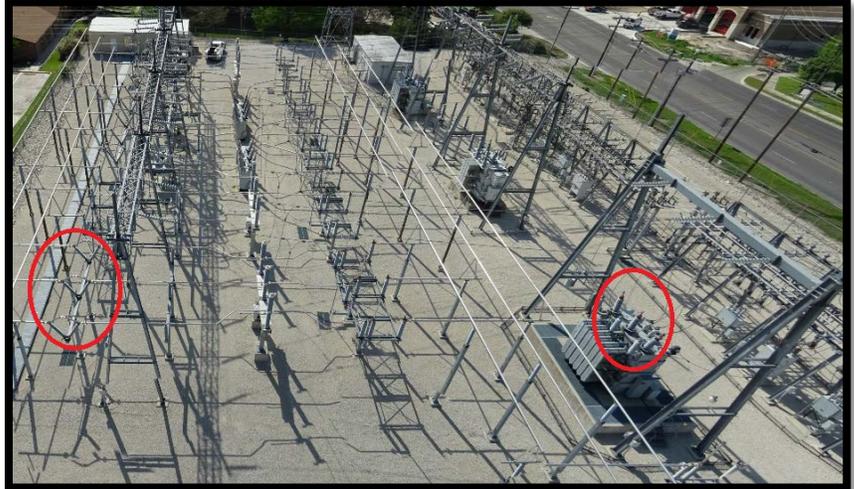
Figure 1. Panoramic View of Substation (highlighted locations indicate area of interest)

The image in Figure 1, shows a panoramic view of the substation. The red circles represent areas of interest where a user can zoom in for as-built configuration clarification as shown in Figures 2 and 3. Using the panoramic images, obtained with the use of a drone, tasks such as verifying the connector type on a switch and verifying externally mounted CT's on a transformer can be accomplished without a visit to the site.

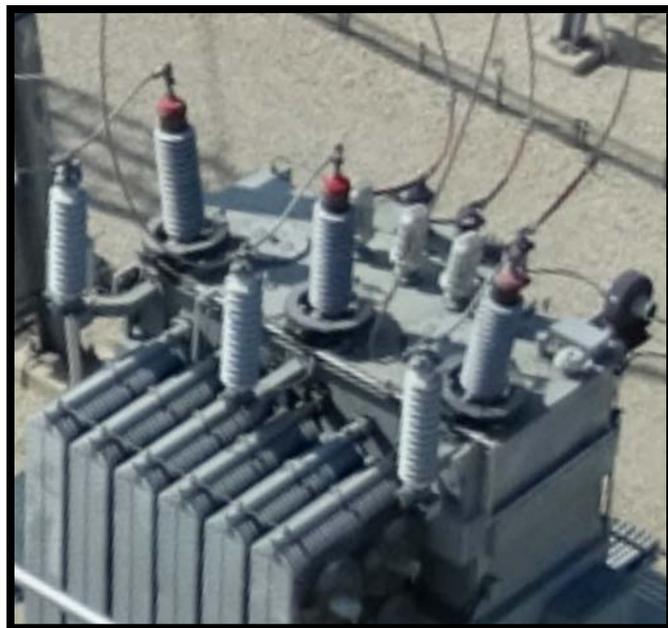
Figure 3. Transformer External CT Verification

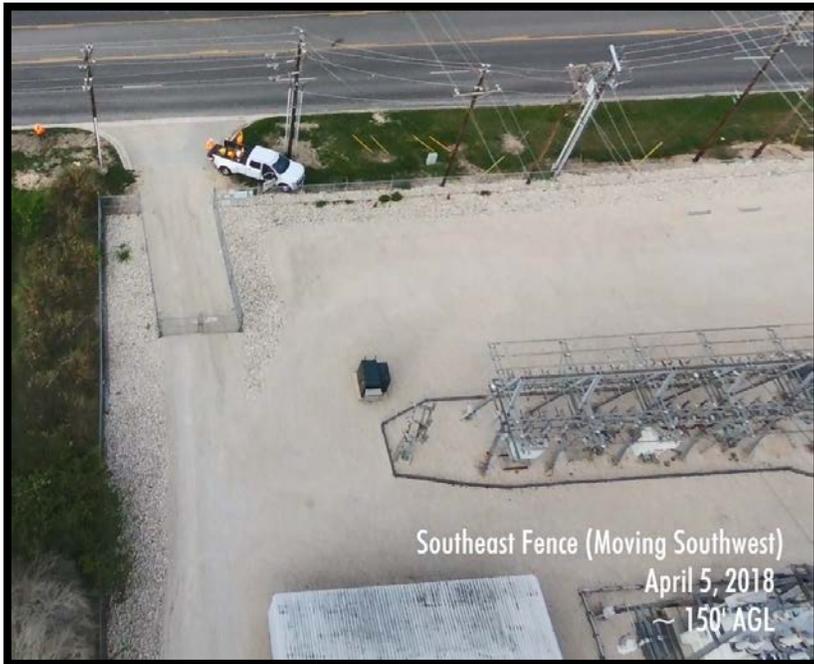
Figure 4. Substation fence line video

multiple ways including making site visits more efficient, and reducing the number of people needed at a site visit. By using drone footage, designers can identify elements that are not captured on engineering drawings and then can focus on obtaining details for these items during a site visit. Additionally, by reviewing drone footage prior to a site visit, design obstacles can be identified. For example, the image in Figure 4 shows an image of the flight path along the southwestern portion of this substation. This image shows perimeter fencing in close proximity to surrounding vegetation which required entrance modification, and perimeter interference due to adjoining distribution equipment.

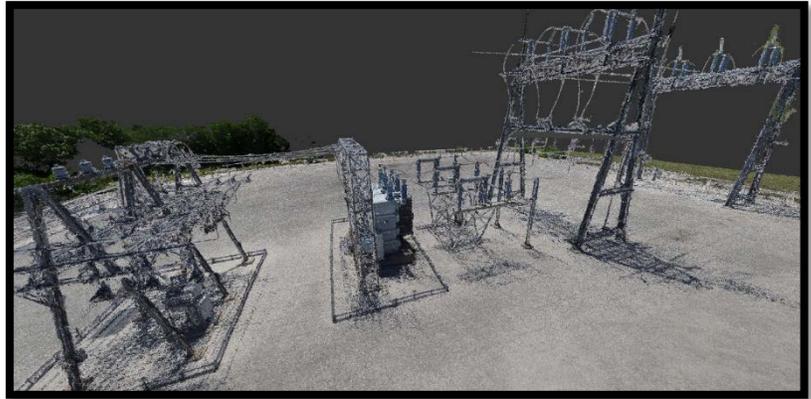
Figure 5. 3D point cloud using LIDAR

Aerial drones have the ability to capture point cloud images with use of multi-camera photogrammetric systems. The photogrammetry offers denser point clouds than LiDAR as the current LiDAR technology has the possibility of not capturing all imagery. With this data, a point cloud is created representing a three-dimensional model of the physical object(s) as shown in Figure 5. This could serve as a useful tool in capturing brown field substations and determining dimensions or clearances, without risking field personnel to exposure of live equipment using hand-held measuring devices. These 3D point clouds could also be used to develop solid models that can be used to create a complete 3D model of the substation.

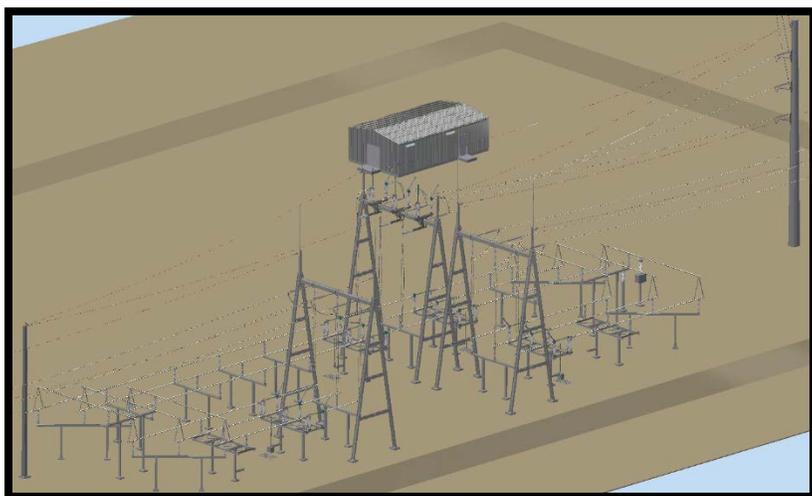
Figure 6. Solid model of a substation using Autodesk Inventor

clearance issues that may be overlooked in traditional designs. 3D designs can also be defined as intelligent modeling due its ability to link all associated drawings to the 3D model, which are automatically updated when the master solid model is changed. Built-in metadata can also be defined in each part or assembly in a substation and with this information a parts list or bill of materials can be automatically generated. As a result of intelligent modeling, there is increased efficiency, added safety due to increased clarification/clearance identification, and drafting error elimination.

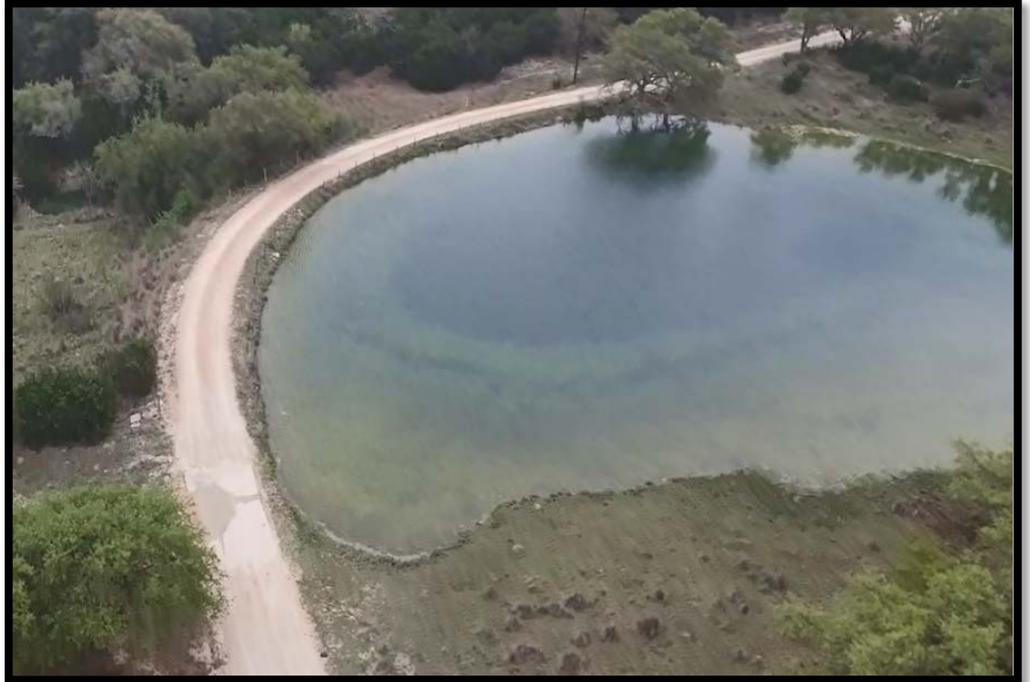
*Figure 8. Potential problematic transmission line maintenance road*

In the project planning phase, for determining transmission line maintenance roads along the transmission line, and in adjacent areas, require inspection. Choosing the best maintenance road can significantly minimize maintenance costs. In a recently executed project, the land for a proposed maintenance road was inspected using drone footage. This analysis showed that the proposed road was going to be problematic and costly. The image obtained by drones in Figure 8 shows the land adjacent to the proposed road had large bodies of water that will problematic if flooding were to occur and could hinder maintenance crews from reaching desired destinations. In addition to large bodies of water, other challenges determined the best course of action was to choose another route.

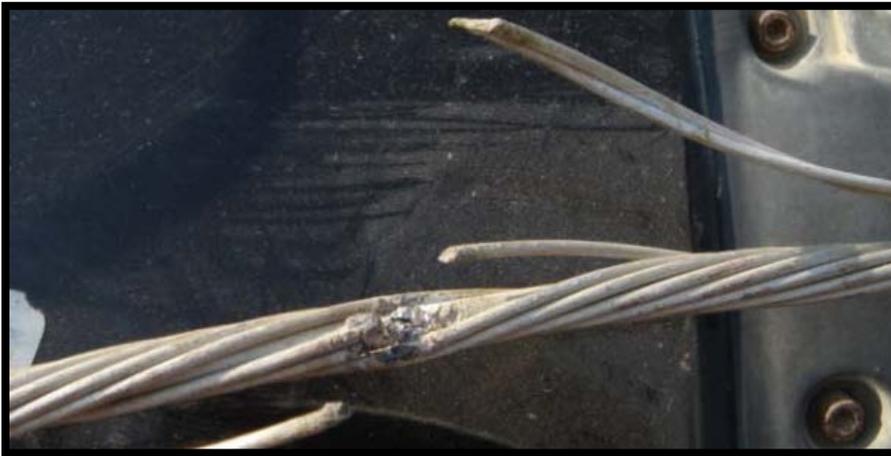
Figure 9. Lightning strike damage on transmission line shield wire.

Lightning strikes are a known threat to the system as shown in Figure 9. The damage shown is evidence of a direct lightning strike to a transmission line shield wire. This damage would be very difficult to detect at ground level using binoculars, and maintenance personnel would need to spend a significant amount of resources inspecting miles of transmission line. Inspecting at ground level could introduce inspection error oversight resulting in damaged equipment being overlooked. Aerial drones can drastically reduce the amount of inspection time and increase the failure detection rate. With multipurpose shield wire, such as Optical Ground Wire (OPGW) with integrated fiber strands, prevention of fiber strand damage can result in increased system reliability.

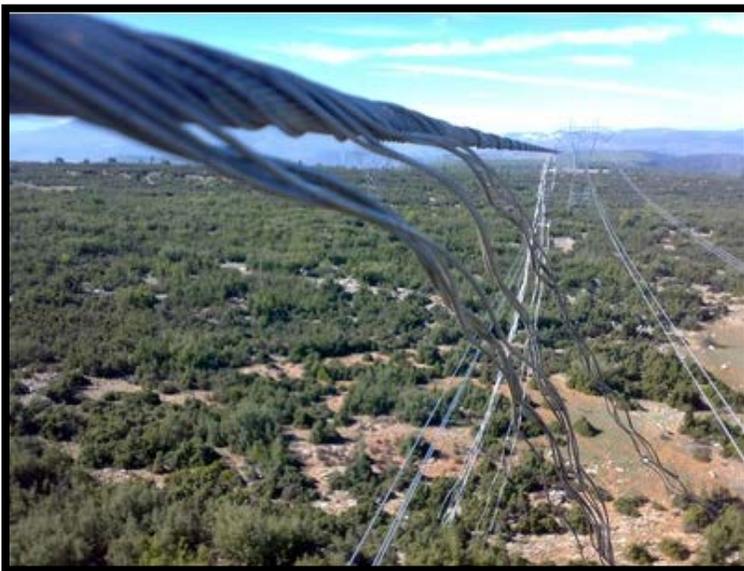
Figure 10. Transmission line shield wire showing evident damage in need of replacement

Mechanical damage of transmission lines or shield wires could also occur as shown in Figure 10. The shield wire shows damaged conductors that may have resulted from over tensioning, aeolian vibration causing strand fatigue, or a combination of the two. The loose strands can eventually come in contact with the live conductors resulting in a system fault.

Exposure to natural elements and phenomenon such as rain, ice, fog, flashover, and corrosion coupled with mechanical abnormality can accelerate the damage of transmission lines and shield wires. Therefore, a periodic UAS maintenance inspection can reduce or eliminate the occurrence of these type of faults caused by damaged equipment.

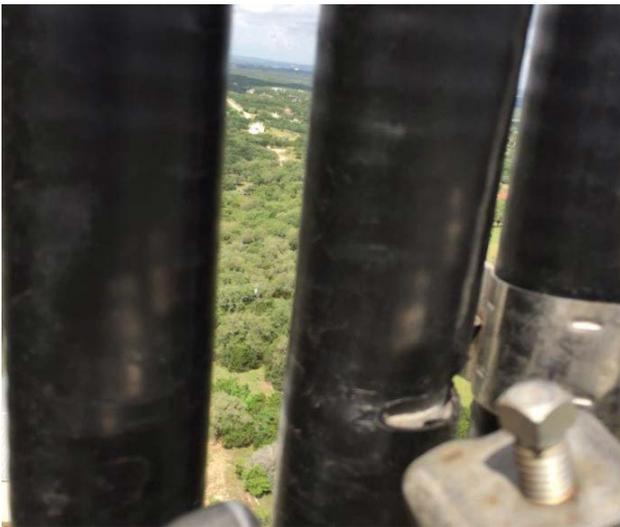
*Figure 13. Microwave tower cabling damage*

In Figure 12, the telecommunication cables have apparent damage that would be very difficult to identify unless an operator climbs the tower for inspection. Figure 13. shows cable damage that was caused by loose or damaged metallic cable restraints. From the image, the culprit for loose or damaged restraints is more than likely caused by the forces of high wind speed. Telecommunication towers require a large amount of time for a thorough inspection that also pose a safety risk for field personnel. Due to substantial heights that operators would need to climb creating a clear concern for safety of these individuals. With the utilization of UAS drones, inspection can be performed without the need of climbing the tower, thus decreasing or eliminating the risk of injury during inspection.
