**Post Galvanizing Toe Cracks in Welds:
Can We Continue to Rely on a “First Aid” Approach to this Problem?**

Wesley J. Oliphant, PE;
¹Principal, Chief Technical Officer, Exo,
e-mail: woliphant@exoinc.com

Zachary J. Oliphant
Principal, President, Exo,
e-mail: zoliphant@exoinc.com

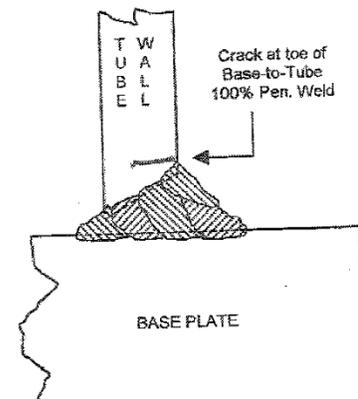
The tubular steel pole industry has been dealing with the challenges of post galvanizing toe cracks in “T-Joint” type welds for more than 45 years. A visual schematic describing a toe crack is shown in Figure 1 (excerpted from EPRI Procedure M-8: Toe Cracks). In 1973, an article appeared in the ASCE Journal of the Structural Division entitled “How Safe Are Your Poles”¹ by Mr. Joseph R. Arena. The article was among the first published that began to outline the importance of welding and weld inspection in the fabrication of tubular steel poles for electrical transmission and substation structures. In the few years prior to the publishing of that article, several large utilities had experienced serious weld cracking issues on their galvanized tubular steel poles. Many of those weld cracking issues were determined through examination to be post galvanizing toe cracks. A toe crack is a crack in a weld that initiates at the toe of the weld where the deposited weld metal and the heat affected zone (HAZ) of the base metal adjoin. When this cracking occurs during, or immediately following the galvanizing process, we have come to refer to it as a “post-galvanizing toe crack”. The major fabricators of tubular steel poles manufacturers are well aware of the issue due to the very specific inspection requirements that

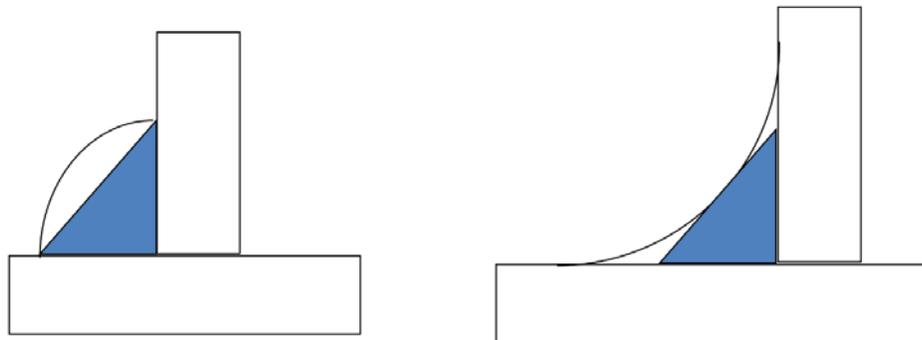
Figure 2

The weld profile can greatly contribute to the stress concentration at the toe of the weld. The Figure below illustrates this. Both fillet welds are considered identical in strength, however the abrupt intersection of the reinforcing fillet weld of the profile on the left is far more susceptible to toe cracking than the gradual transition of the fillet weld on the right. Fabricators paying attention to this detail during welding and quality control checks can minimize the influence of this type stress concentration / stress riser.

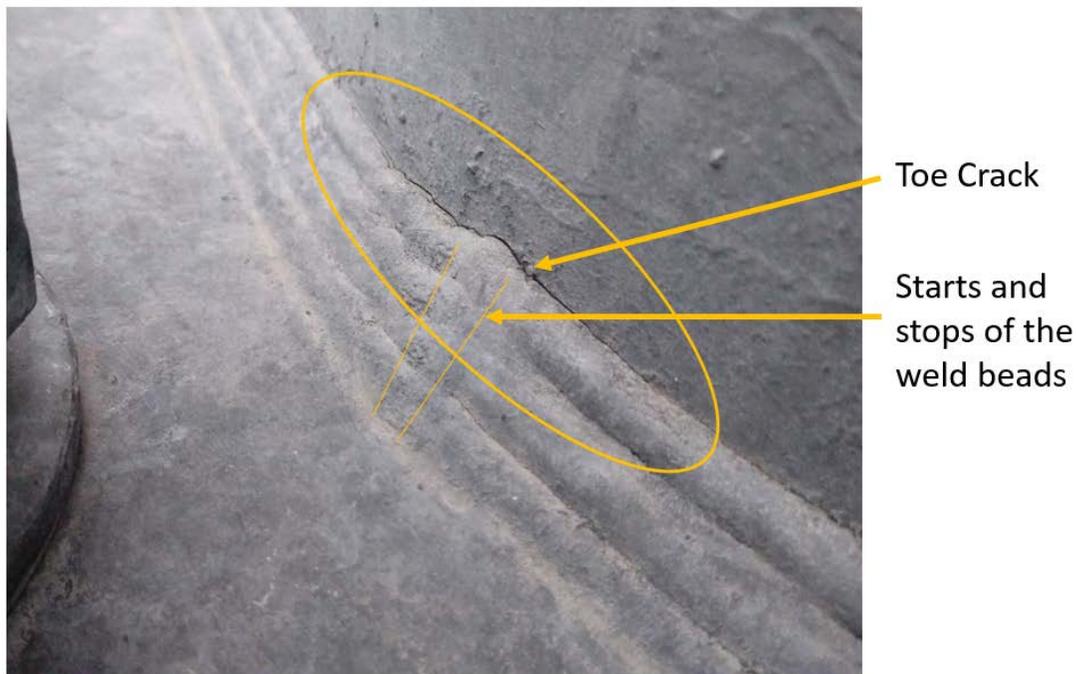
Weld pass “starts” and “stops” can create stress concentration or stress risers, particularly if they occur on the bend lines of the pole shaft. This is illustrated in Figure 3 below. The circled toe crack that occurred is on a bend line, and the pass “starts” and “stops” are evident on the individual passes at that location as well. A better practice would be to minimize this contributing factor by welding the passes from mid-flat to mid flat, thereby placing these potential stress concentrations / stress risers in a lower stress region of the weld.
